Service Bulletin

Bulletin No.: 21-NA-260

Subject: Lack of Power or Poor Performance During High Ambient Temperatures with RPO (C7N) 12,300 LB GVWR or (C4M) 9,900 LB GVWR

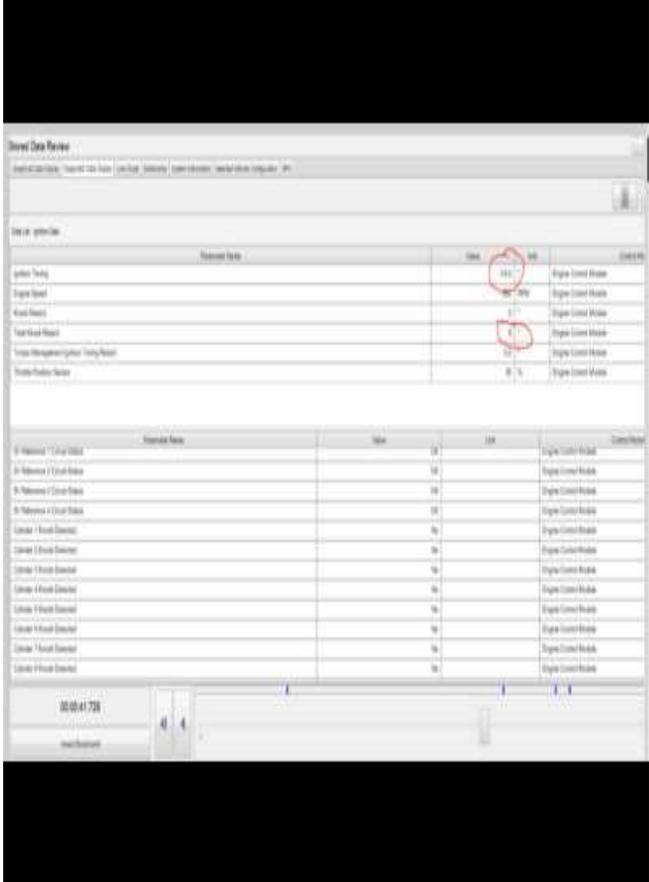
<p style="text-align: right;">5923409</p> <p>The cause of the condition may be high ambient temperatures 90 degrees (32 Celsius) effecting the intake air flow to the engine. When looking at GDS2 scan tool data you may also notice an increase in total knock retard and ignition timing being backed out (chart shown above). This can occur while the vehicle is underload or driving in a situation where they may be going up a grade and more throttle input is required. The ECM is adjusting to protect the engine from engine damaging spark knock, which are normal under these conditions.</p>
<p>Correction</p>	<p>A new air inlet duct extension has been released to fix this concern. Before installing the new air inlet duct extension, please inspect the following list of items to ensure they installed correctly, and not missing or damaged. If any one of these components is missing or damaged, this could allow hot air into the intake duct causing the lack of power concern and must be corrected as well.</p>

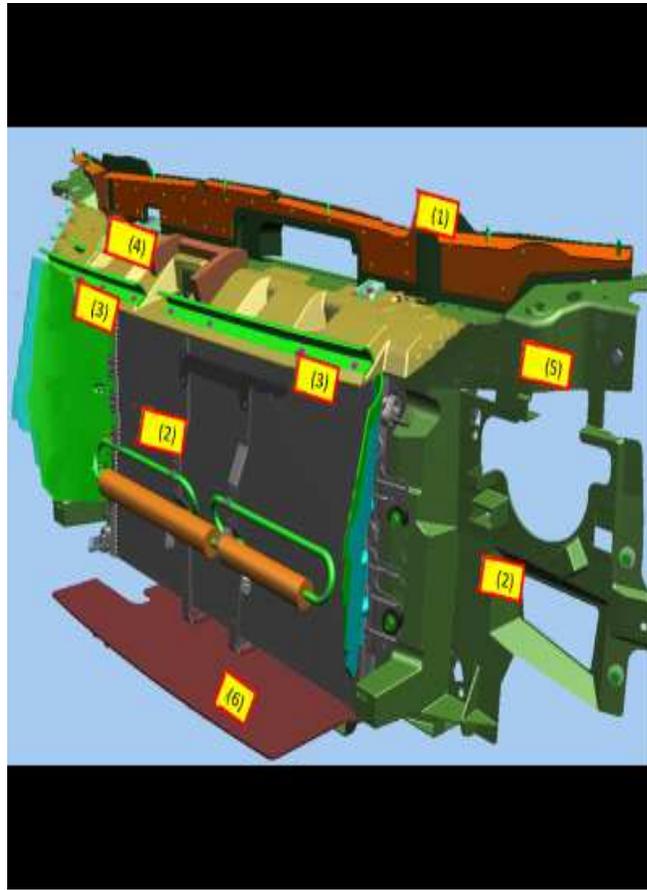
5923357

- Is the hood seal installed (1) ?
- Are both CRFM side baffles, driver and passenger side, installed correctly (2) ?
- Are both grille seals installed correctly (3) ?
- Is the hood latch seal installed correctly (4) ?
- Is the radiator upper baffle installed correctly (5) ?
- Is the lower baffle installed correctly (6) ?
- Is the air box end cover installed properly ?
- Are all intake air ducts installed correctly and clamps tight ?
- Is the PCV hose installed correctly ?
- Is the air box attached to upper tie bar with correct fasteners and secure ?
- Has the up-fitter installed components in front of the grille, blocking fresh air flow to CRFM ?
- Has the up-fitter modified anything to attach their components ? (Baffles, fascia, hood seal or anything else)
- Are there any holes cut/drilled in any sheet metal near the AIS inlet ?
- Inspect the intake duct for any restrictions.
